Degradation of Estonian Lighthouses in Surrounding Environment

Jaan Vali

Estonian National Heritage Board

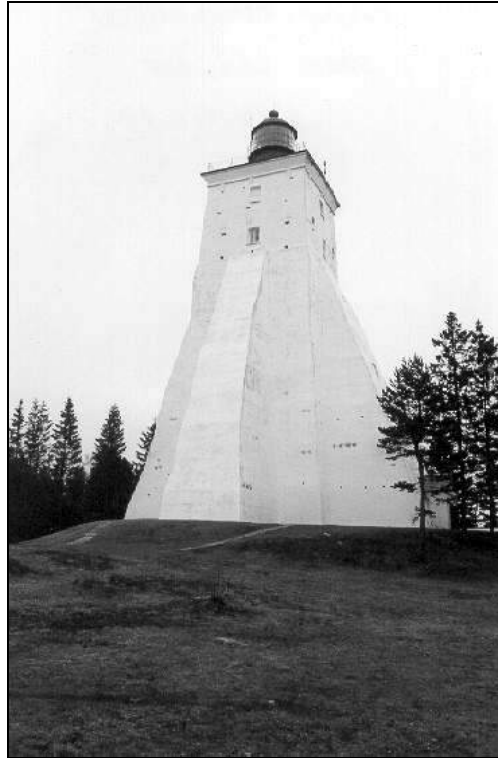
Kõpu lighthouse (1)

The body of Kõpu lighthouse is built without using mortar, only the outside layer of the walls is supported by lime mortar. Already in the beginning of the 20th century problems emerged regarding the structure of the massive body. As a possible solution walls were plastered with cement mortar. During the 1980ies part of the walls came down. In order to stop the lighthouse from crumbling down the lower part was cast into concrete. Small air channels were left into concrete to allow the lighthouse to breathe.

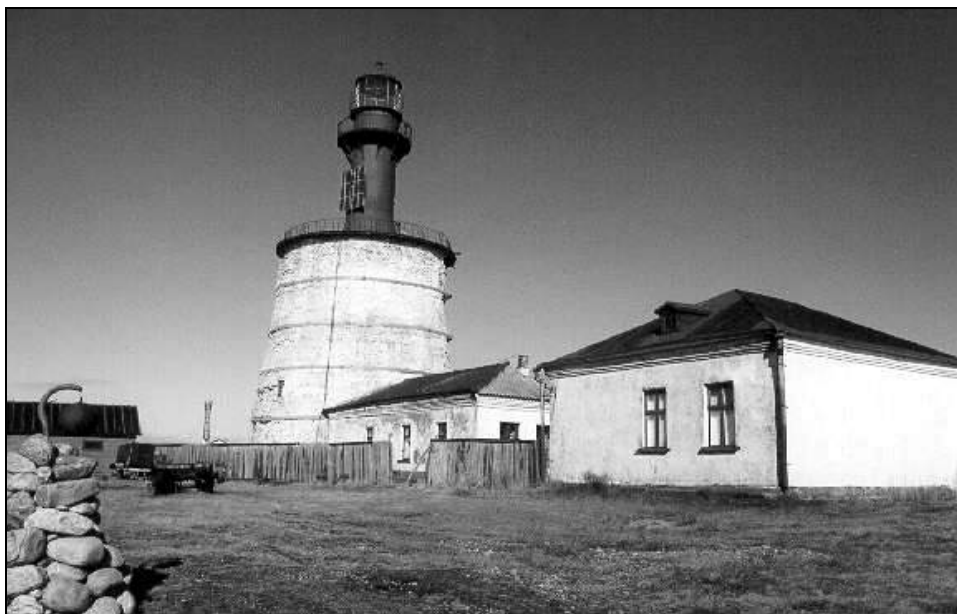
Keri lighthouse (2)

Keri lighthouse, located on a small islet without any port in the middle of the Finnish Gulf, is on the verge of falling into pieces even today. Metal strips placed around the body of the lighthouse prevent it from immediate decay. Preservation and repair of this historic lighthouse will cost a lot and is at the moment not affordable for the state.

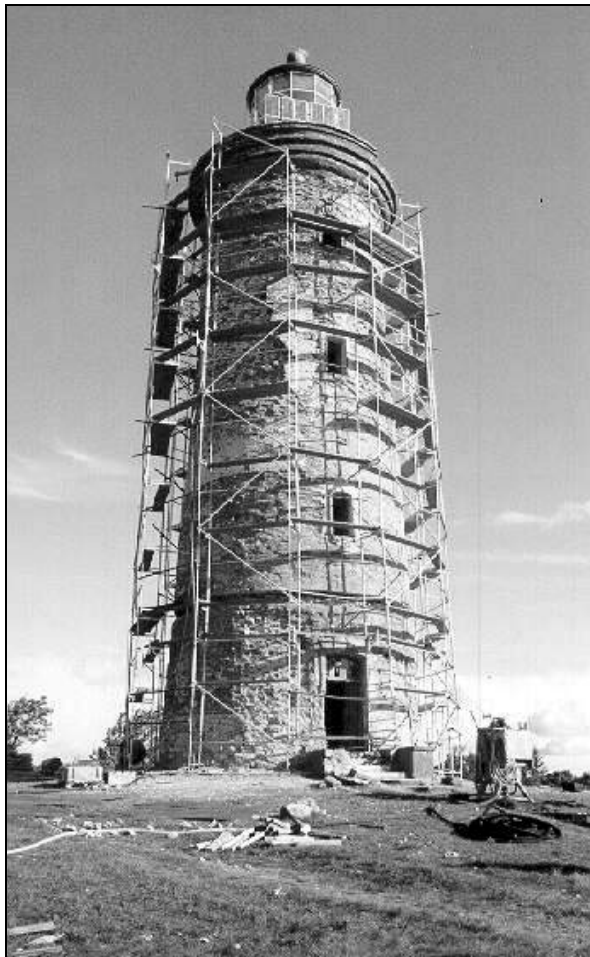
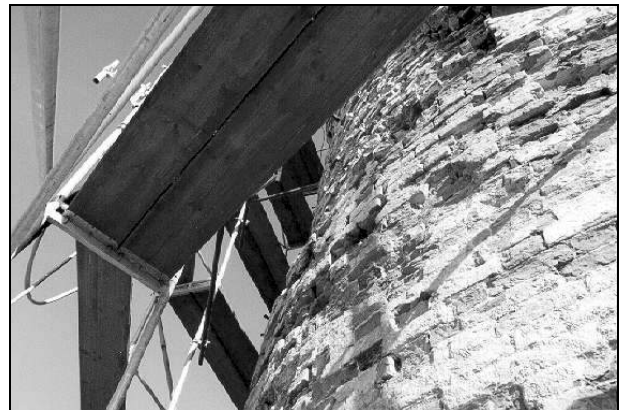
Mohni lighthouse (3, 4)

Brick as a building material for lighthouses in Estonia has in most cases proved to be improper. It is not strong enough under extreme weather conditions and decays easily, especially on the sides facing south and west, where temperature fluctuations are the greatest. Later attempts to cover brick walls with plaster have also not given the expected results.

One of the reasons why the cement plaster has not improved the situation may be that cement in the plaster has created a layer that does not allow the building to breathe anymore.

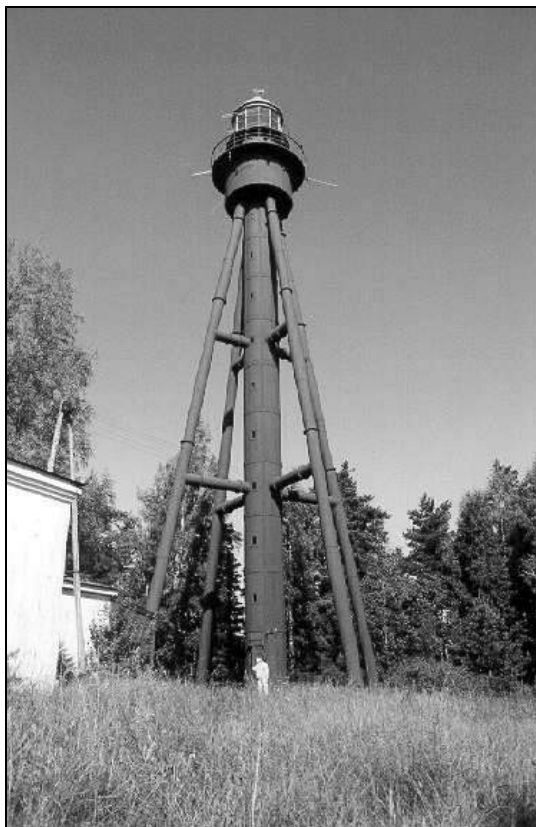
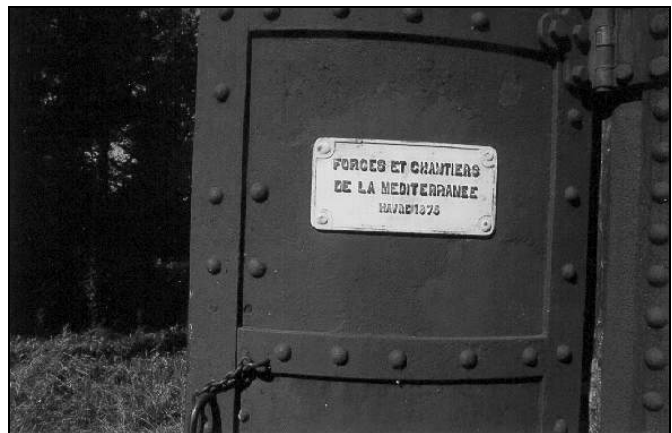
Ruhnu lighthouse (5, 6)

There are three boiler plate lighthouses dating from the II half of the 19th century in Estonia. All three have been greatly damaged during wars. Two of the lighthouses, Ristna and Viirelaid, were covered with concrete. The steel construction acted as a reinforcement in the concrete. The upper part of the third lighthouse in Ruhnu was completely demolished in war. An analogical upper metal construction was added to the lighthouse after the World War I.

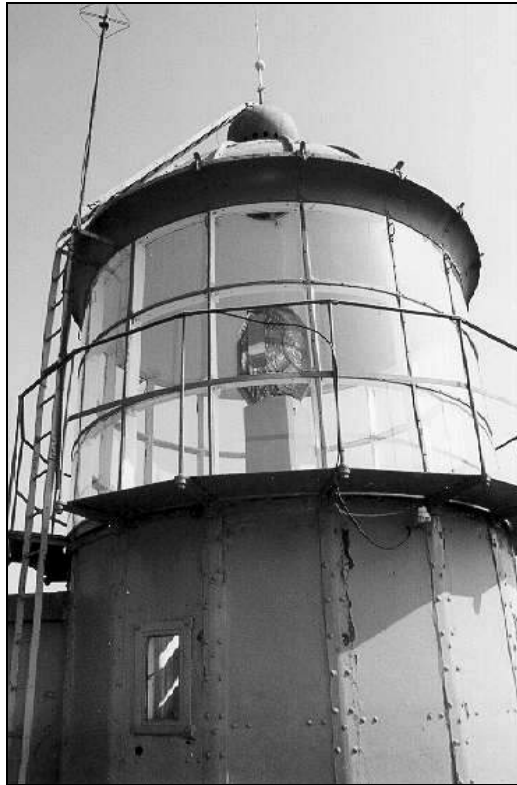
Lanter of the Kõpu lighthouse (7)

For the construction of lantern rooms different materials are used. Supporting pillars are made of cast iron; the body of sheet iron, glass and wood; the cupola from bronze. The contact points of different metals tend to corrode very intensely. During the 1990ies several lighthouses have been thoroughly repaired. It is very expensive to repair the lantern rooms. There is grounds to believe that the polluted moist sea air quickens the corrosion of metal constructions. Unfortunately no systematic long-term analyses have been carried out to monitor changes that affect lighthouses. This can partly be explained by the fact that until recently lighthouses were administrated by the Soviet Navy.

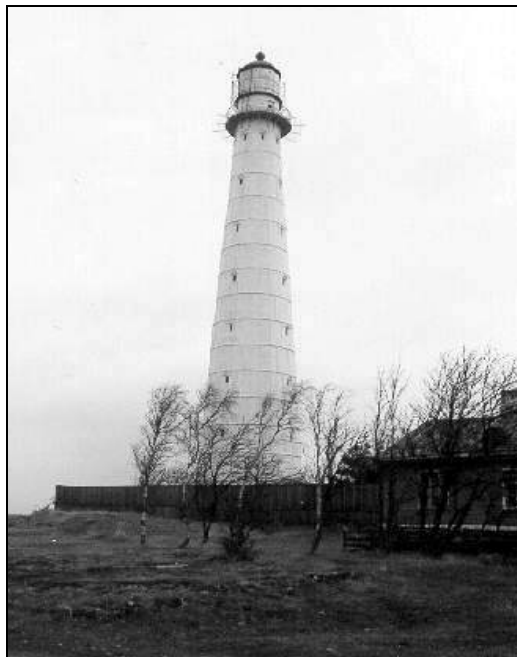
Tahkuna lighthouse (8)

Maintenance of cast iron lighthouses is slightly cheaper, as cast iron does not corrode as easily as iron. Equally, it is also fairly simple to clean cast iron from old paint and corrosion. One of the problems, however, are the bolted joints of cast iron constructions that tend to let water in. Four cast iron lighthouses dating from the II half of the 19th century have survived in Estonia.

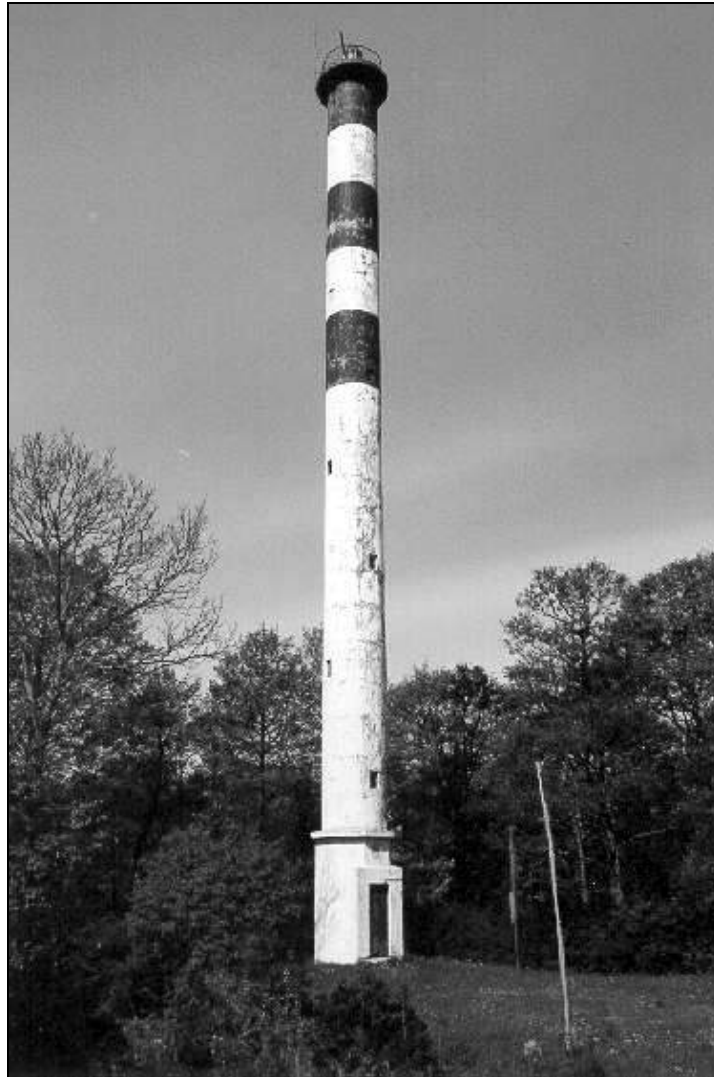
Abruka lighthouse (9)

reinforced concrete is the most weather-resistant material, it requires minimum care. At the same time it is also true that the earlier reinforced concrete lighthouses already suffer from damages on the concrete surface and the reinforcement. The concrete surface has in some cases developed holes into it, steel reinforcement has uncovered and started to rust. The reason for that might be that water has invaded into concrete and the reinforcement has started rusting. This in turn causes expansion of the reinforcement, which will in time demolish concrete. Still, these processes are relatively slow and if detected in due time can be repaired with small effort and good maintenance.

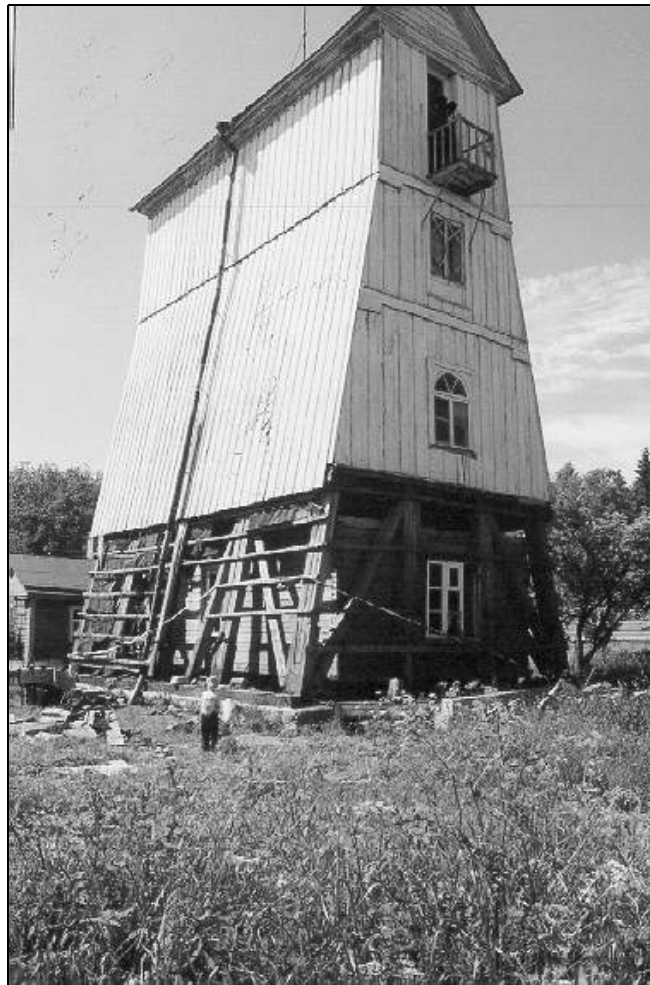
Suurupi lower lighthouse (10)

There are two wooden lighthouses in Estonia. Wood has always been considered as temporary building material for lighthouses. But as the saying goes – nothing is more permanent than a temporary thing. The oldest wooden lighthouse in Estonia – Suurupi Lower Lighthouse - dates from 1859. This is apparently the oldest wooden lighthouse in the Nordic countries. Restoration work on the lighthouse was done in 1998. During restoration the support constructions of the lighthouse were repaired near the ground level, also exterior wooden boarding was renewed. As the lighthouse has a well ventilated construction, there was not much damage done to the wood. The tower has also seen regular repainting.
