Restoration of Wooden Structures

Juhani Penttimikko, B.Sc, Md

Penttimikko consulting engineers Ltd, Finland, mobile+358400459496

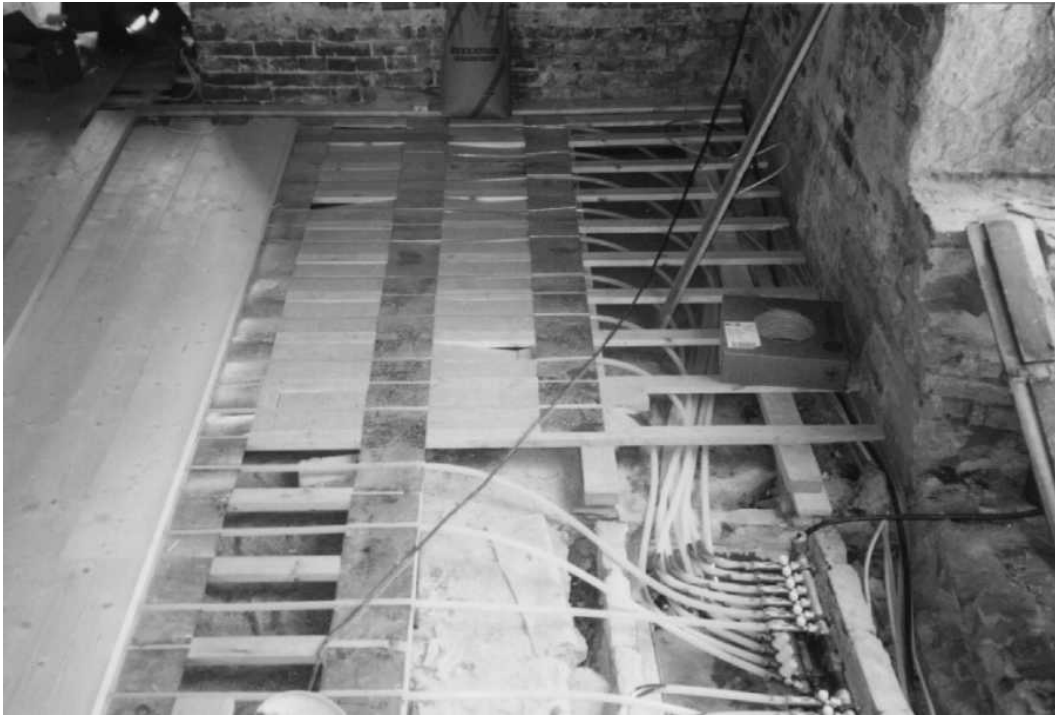
5. *Tenaille von Fersen, floor construction*

So the work was done so that the brick floor was covered with filterfabric. Above that the floor supporting rails were installed, and under them there was a neopren. In between came a layer of sand. Floor heating pipes were installed under the whole floor space. Between the supporting rails were mineralwool installed to deaden the echo. Finally, floor boards were installed. At first the floor was so dry that the boards had to be quite wide apart. When the structure got damper the floor tightened. A ventilation gap was left around the surrounding walls. The structure proved to be very good as far as acoustics were concerned, and today it's a popular place to have small classical concerts.

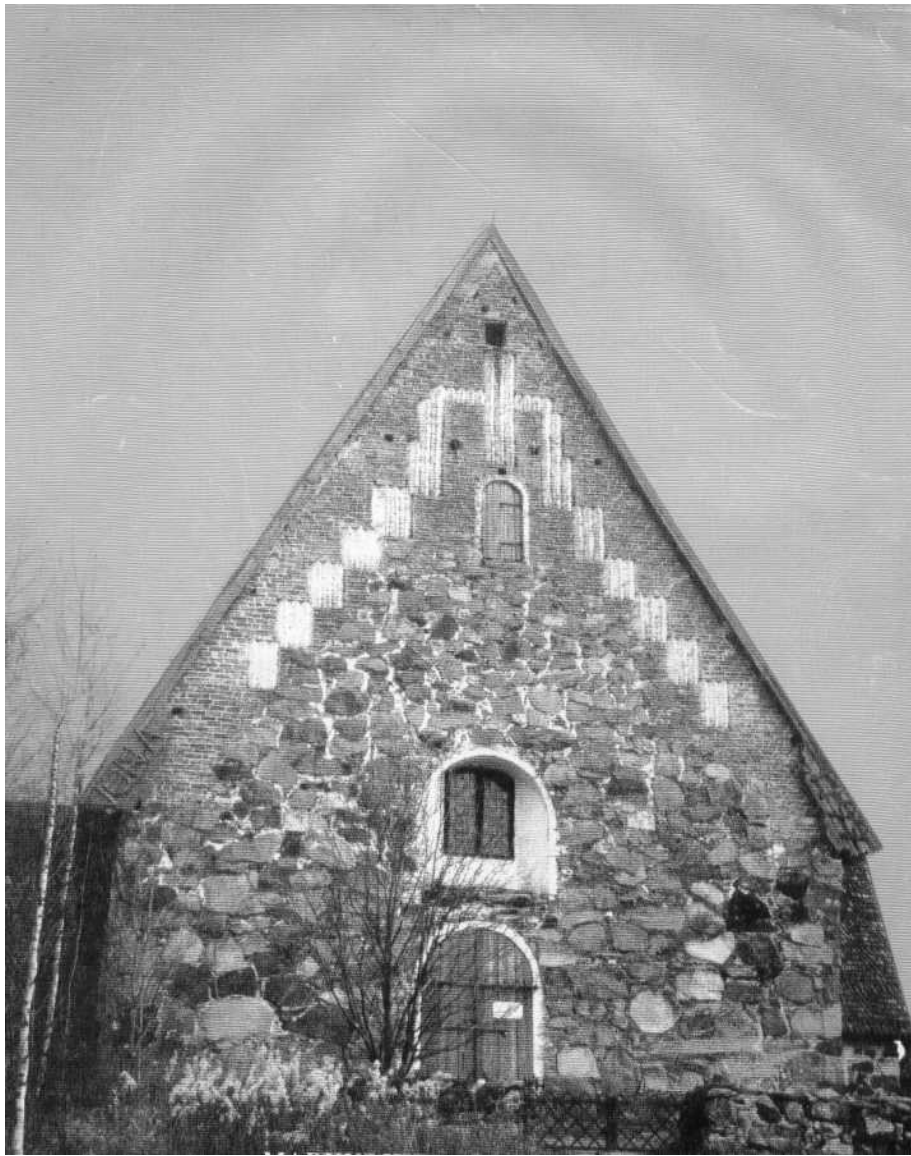
6. Tyrvää church

Roof trusses were reconstructed. The joints of the roof trusses were made with wood tenons. Their strength met today's norms in almost every case. Only in the critical joint on the wall where the horizontal loads are biggest, the wooden tenon was replaced by a steel bolt. The interior was to be reconstructed, too. It was a natural choice to follow the original construction style. And nails weren't to be used, either. All the wooden joints were to be designed according to old notching methods. Carpentry was made by voluntary pensioners. They have had all the necessary stamina and skill to make the demanding joints and to develop suitable solutions further. The realization is now on the homestretch. One of the most difficult parts has been the construction of the balcony's railing. The aesthetic demands of the railing and the ban to use nails have been a real challenge. The solution has been found. In a way "gunpowder has been invented anew".

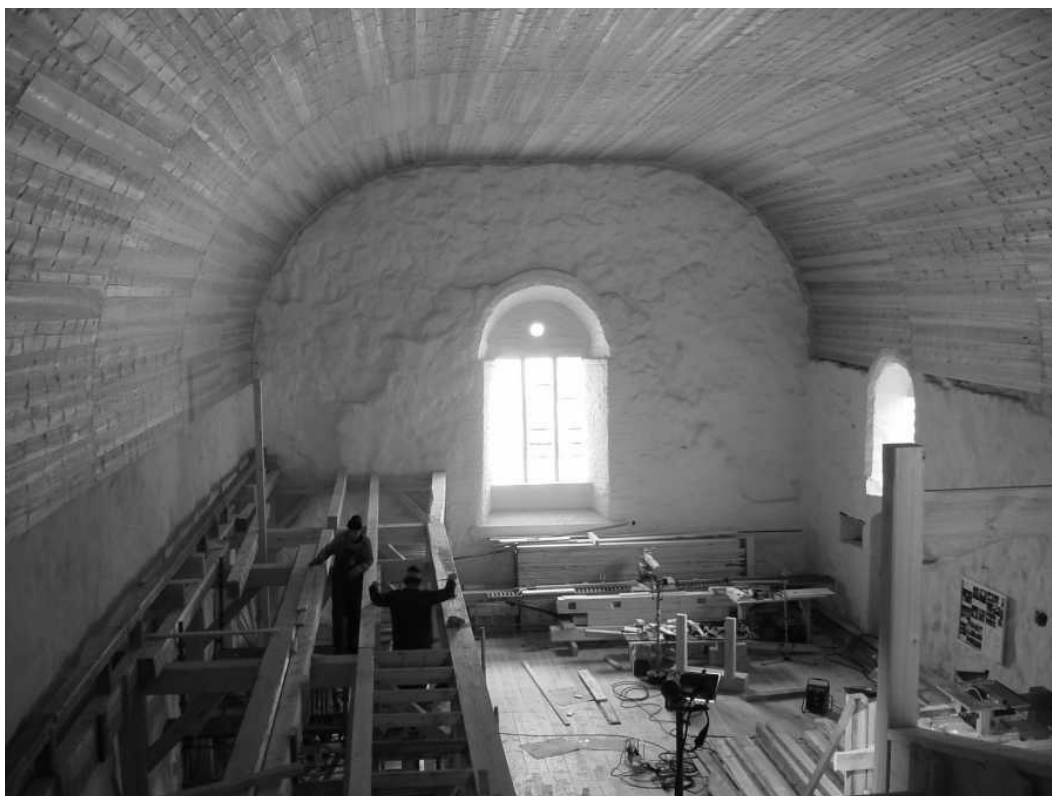
7. Tyrvää church, under reconstruction

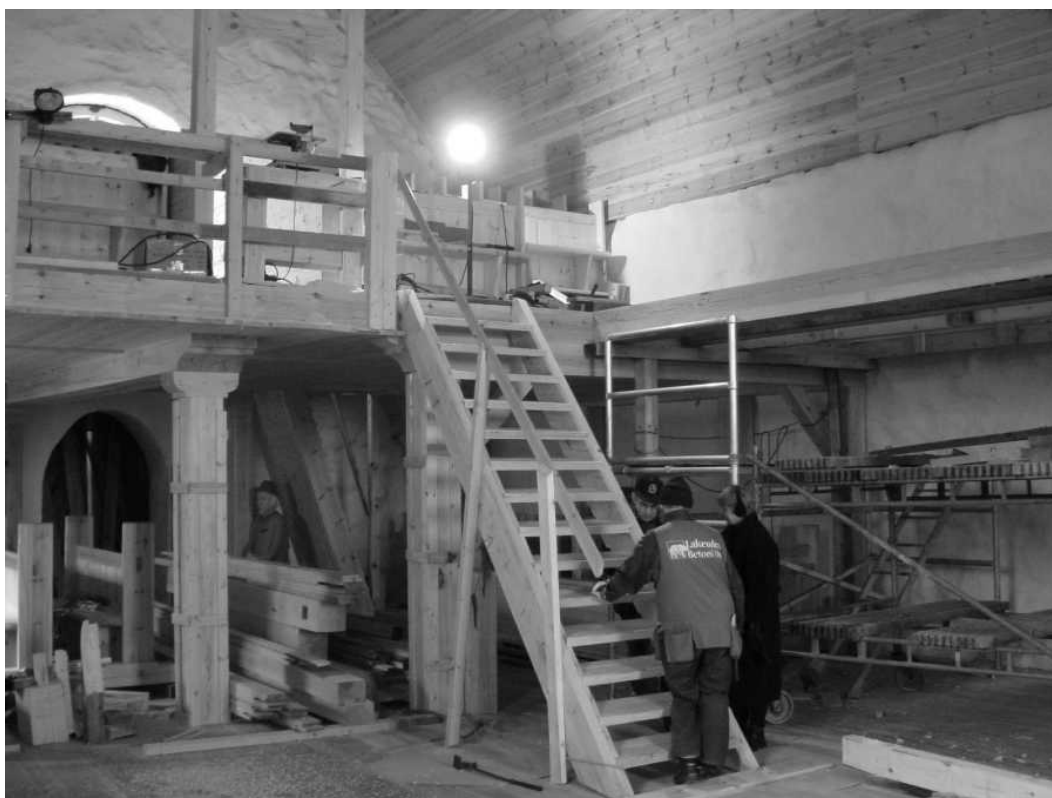
8. Tyrvää church, rebuild balcony

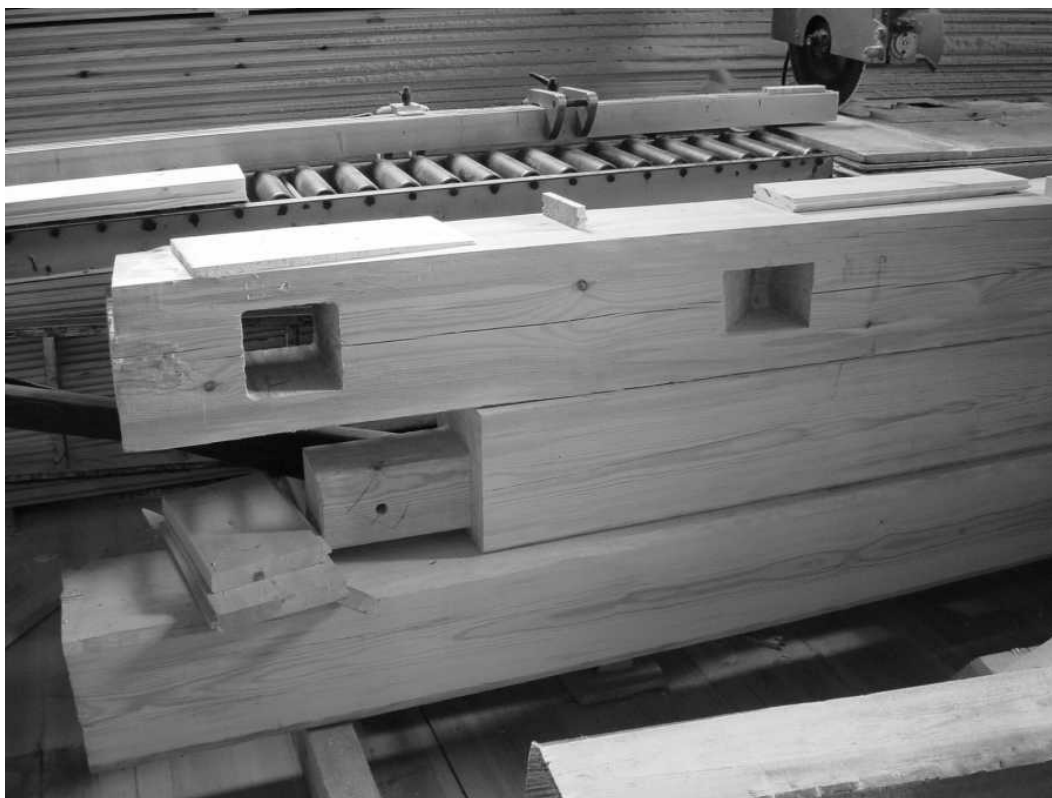
9. Tyrvää church, holes for joints

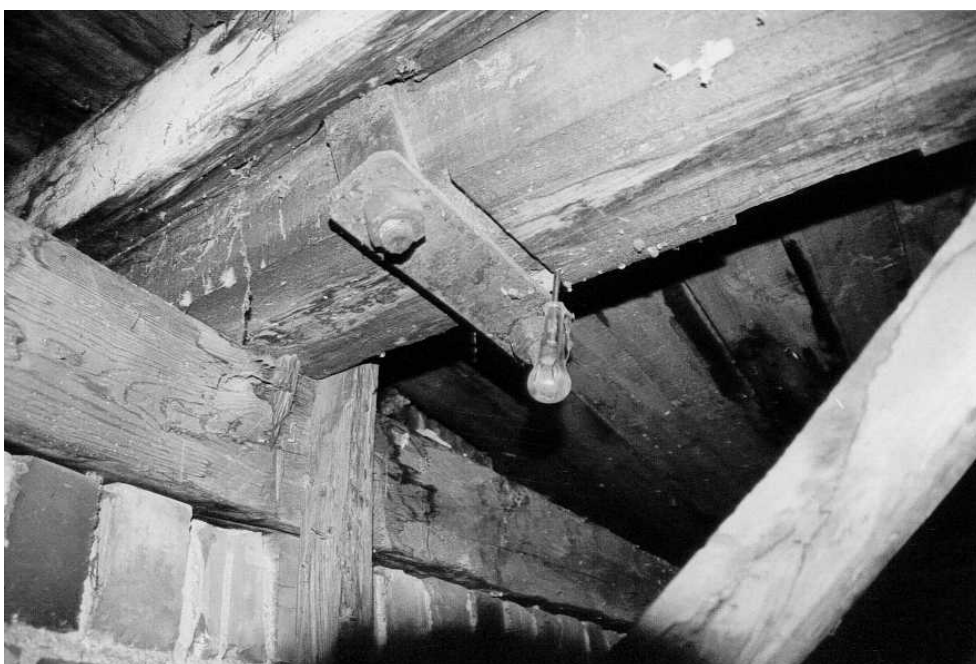
When I surveyed the condition of Suomenlinna's manege C 81 almost ten years ago, I found alarming rot in the roof's lattice girders. The otherwise uninsulated roof structure had at some point been insulated by mineralwool jusa under the gutter area. Roof leaks and damperroof's condensation had got into the glass wool, and that's why the girders were rotting. The building served at that time as Suomenlinna's labour colony's warehouse, and it was not easy to find them a replacement quickly for the time of the reparation. At last such a place was completed in 2000.

12. Artillery manege, rot examinations

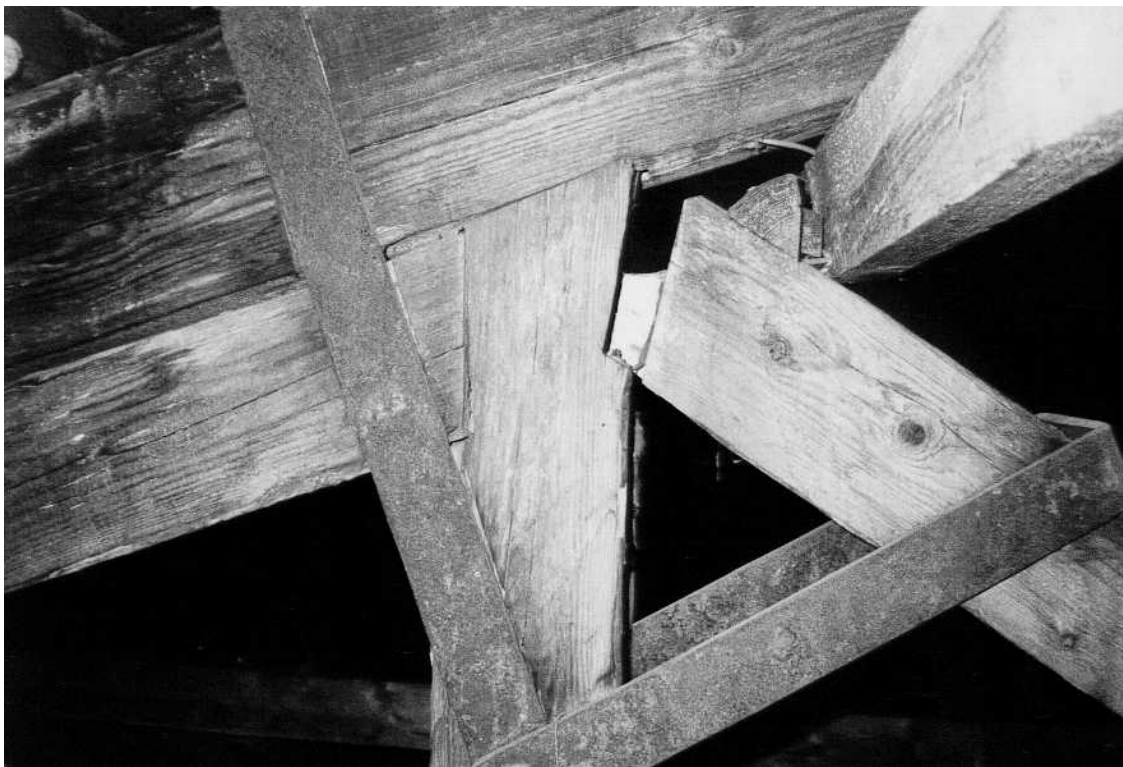
13. Artillery manege, bad joint

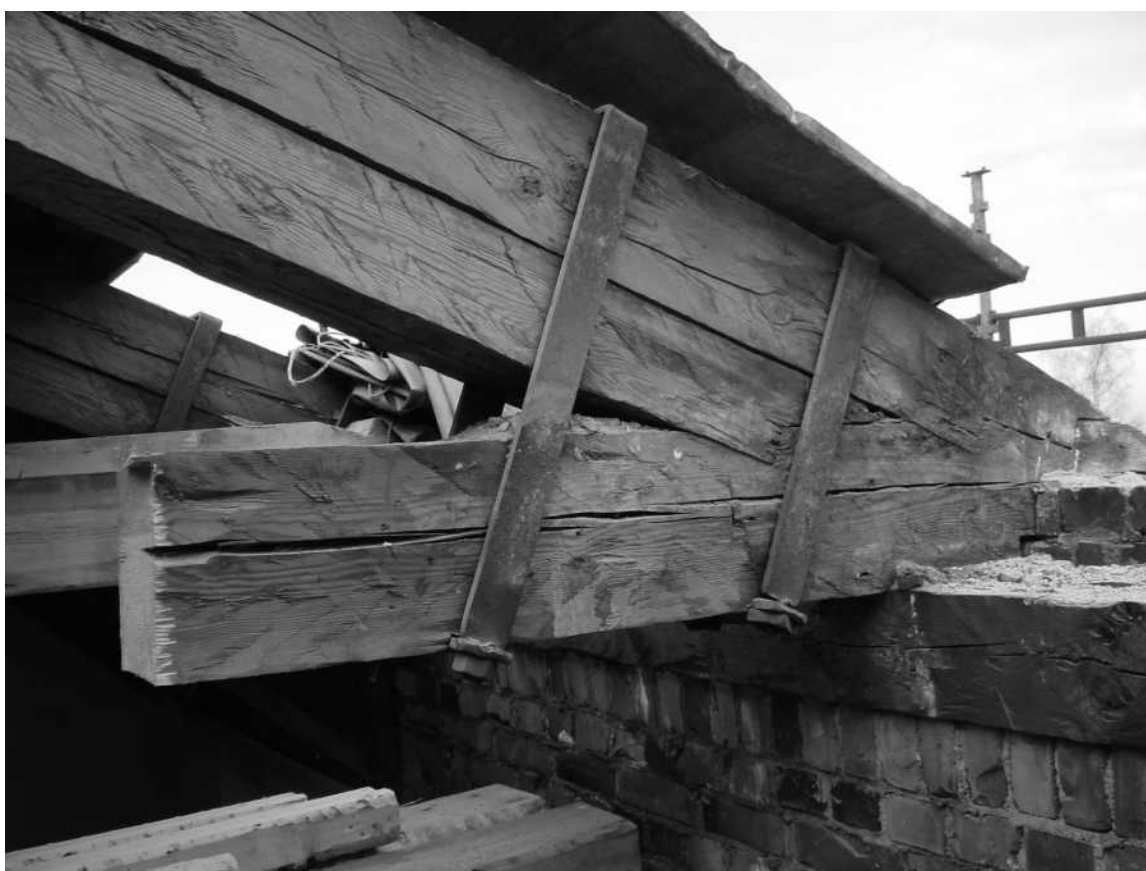
14. Artillery manege, restauration in progress

The roof reparation was begun in January 2001. The work was done by the convict labour. After the starting difficulties the labour learned the right methods, and the project quickly progressed. Today all the 20 girders are repaired, and the building will soon get a new tin roof. Convict carpenters developed with the work into skillful restauration experts.

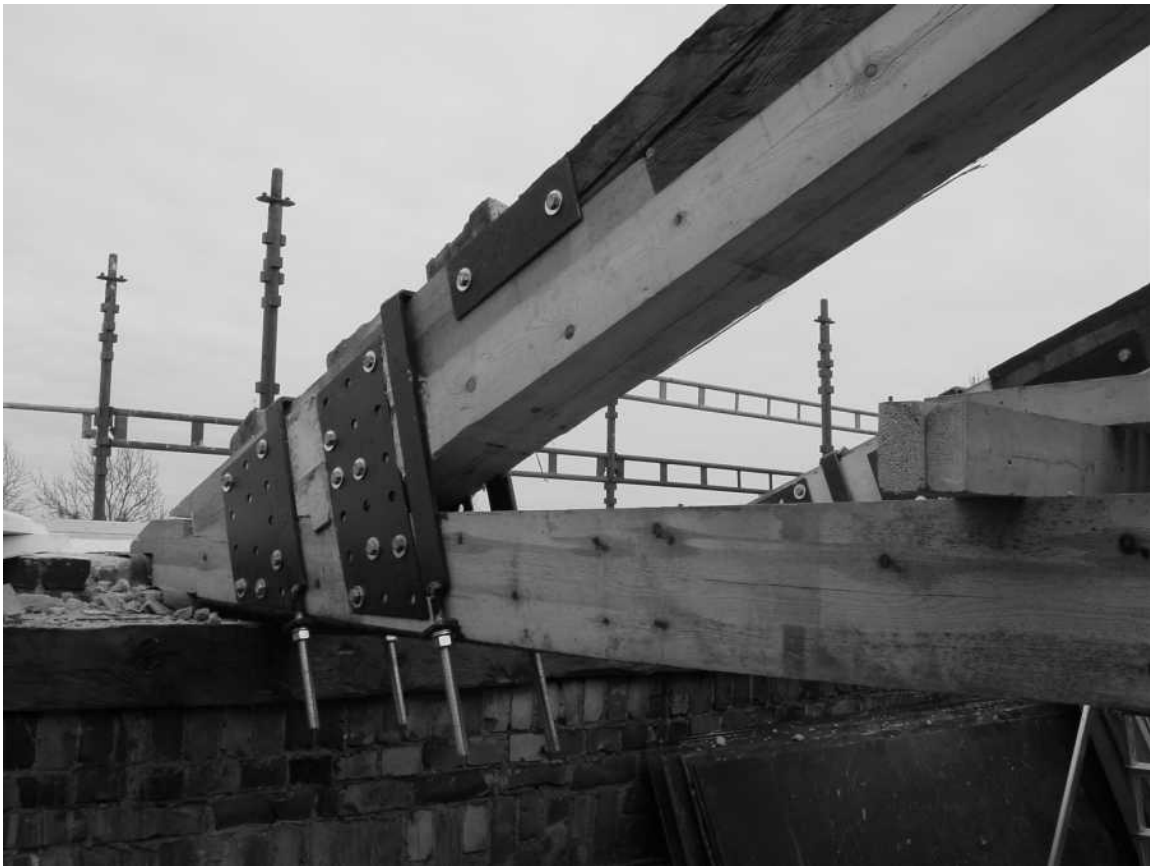
15. Artillery manege, joints has strengthen

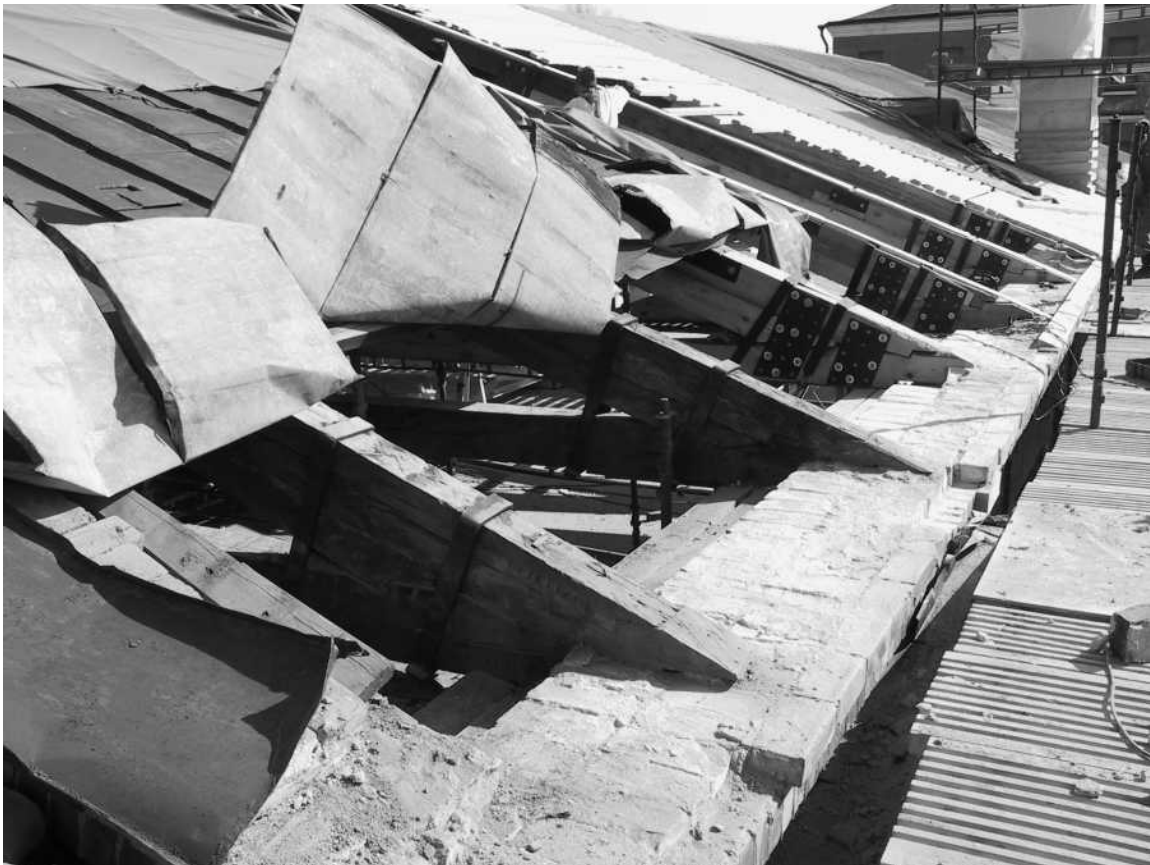
16. Artillery manege, restauration in progress
