# Fluorosilicates (“fluats”) used in the past in the conservation of stone in Central Europe

Ivana Kopecká<sup>1</sup>, Vratislav Nejedlý<sup>1</sup>, Lubomír Kopecký<sup>2</sup> and Jiří Novotný<sup>3</sup>

<sup>1</sup> National Institute for Cultural Heritage, Central Institute in Prague, Czech Republic

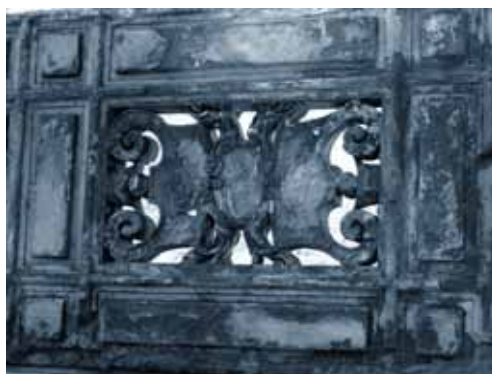
Figure 2: Perfectly conserved areas of the surface of stone and areas from which the fluted layer has broken away

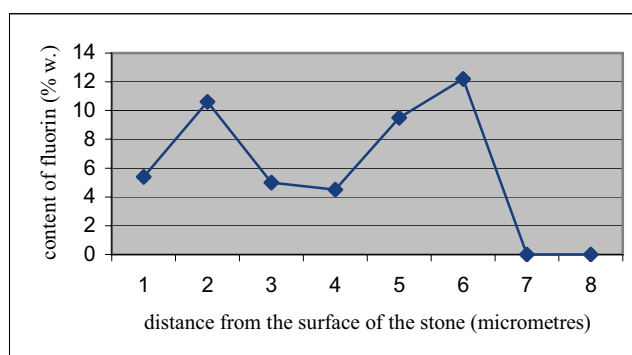
Figure 3: Relative content of fluorine in accessory elements in the top layer of the stone depending on the distance from the surface

Last year thanks to advanced instrumental analytic technology fluorine was identified in a thin layer on the surface of the stone. Several samples of stone surface were analysed (as cross sections, in different distance from the surface of stone) by the scanning electron microscope XL 30 ESEM-TMP PHILLIPS equipped with the EDAX<sup>®</sup> multichannel X-ray spectrometer for elementary microanalysis. The ESEM<sup>®</sup> mode (i.e. environmental mode) facilitates measurement in the different vacuum level in the chamber of the microscope and different environmental conditions (wet, dry), and makes elemental analysis of non-conductive materials without metal coating possible. Due to the ultra thin window of the EDS X-ray detector this instrumentation can be used in quantitative analysis of light elements as is the case of fluorine. Fluorine was detected in a very thin layer on the treated surface of stone. The morphology of this layer is completely different from that of non-treated stone (fig. 1). The dependance of the content of fluorine on the distance from the surface of stone is documented in fig. 3.

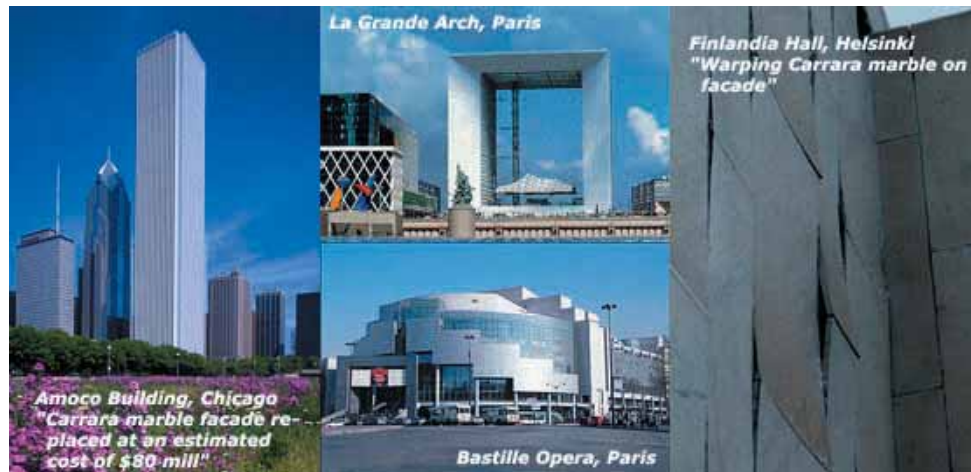
It was concluded that the phenomenon of bowing of marble is actually rather common. It is observed in buildings of various ages, in buildings exposed to various weather conditions and for slabs of various thickness and dimensions and with different anchoring methods. The problem is not restricted to one type of marble or one climatic zone. It is also equally important to draw the attention to the fact that many marble and limestone claddings and pavements tend to be durable and robust, provided that the correct quality has been used. However, the facades receiving the most sunlight exhibit the highest percentage of bowing. Both concave and convex bowing can occur on the same facade with the same marble. There is a clear correlation between bowing behaviour and deterioration leading to loss of strength. It cannot be stated that non-bowing stone slabs are not deteriorating and loosing strength. There are quite a few different types of marble of different origin related to quarry areas that demonstrate the bowing behaviour. Marble types or selections from same quarry area can demonstrate bowing as well as non-bowing behaviour.

*Figure 1: Bowing phenomenon observed on modern buildings*

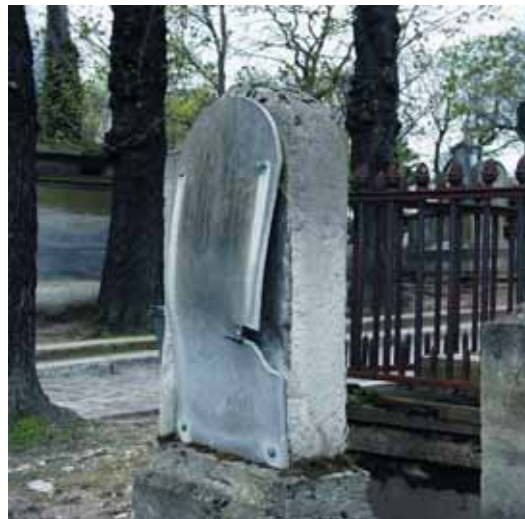
*Figure 2: Bowing phenomenon observed on old gravestones, Paris*

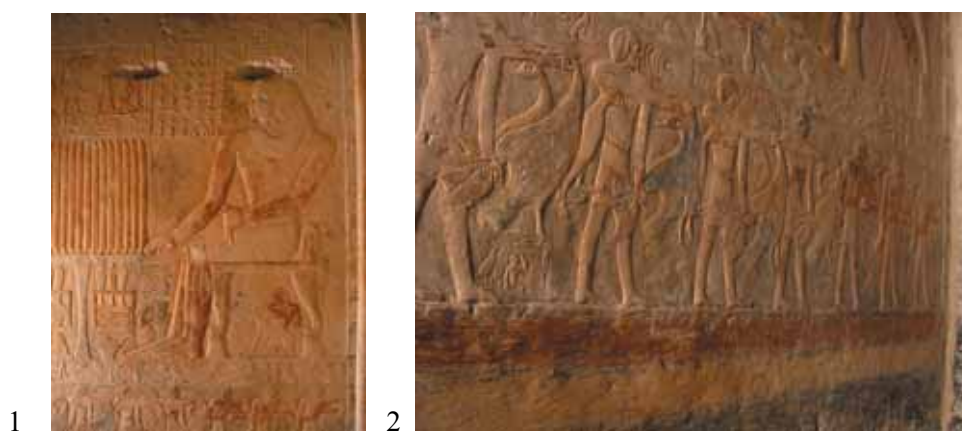
*The main scenes from the funeral chapel depicting owner of the tomb Inti /1/ and offering bearers /2/ in technique of polychromed relief after conservation*

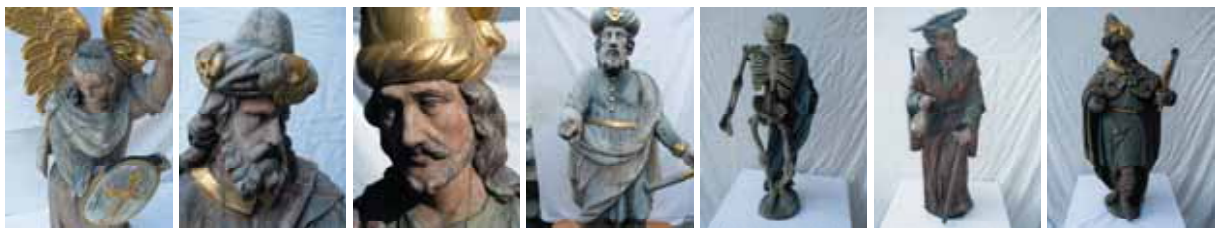
## Condition before Restoration

Restoration started in 2005 because all the wooden statues from the Prague Astronomical Clock's facade were in a very poor condition. Most of the polychromy of the statues (approximately 90 %) was missing, the wood was cracked, greyish and much degraded. This happened because the sculptures are situated outdoors, on the southern facade, where they are exposed to sunshine (UV radiation), rainfall and strong climatic fluctuations. To ensure maximum protection of the wooden statues a procedure for their conservation was carefully selected as acrylate agents used in the last restoration proved to be unsuitable due to the location of the statues. Therefore alkyd-urethane protective varnish was selected because of its very good resistance against weathering.

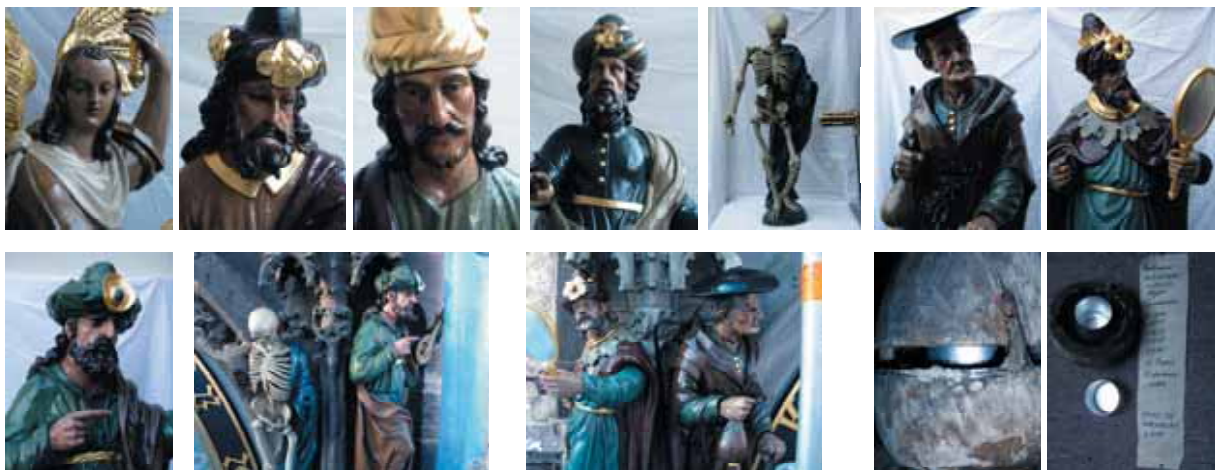
## Condition after Restoration

1. Cleaning, taking out of damaged fillers and unblocking of non-cohesive connections
2. Filling of the cracks and repairing of connections – thin cut veneers and polyurethane based glue
3. Consolidation of disturbed wood and polychromy – alkyd-urethane paint
4. Filling of the missing polychromy – alkyd-urethane paint, wooden powder and pigments were used as filler
5. Unifying by means of retouching
6. Final protection – alkyd-urethane paints in three layers
7. Gilding and silvering

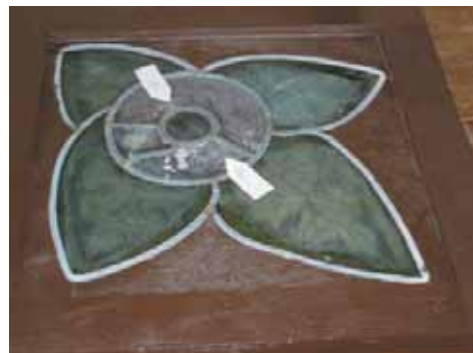
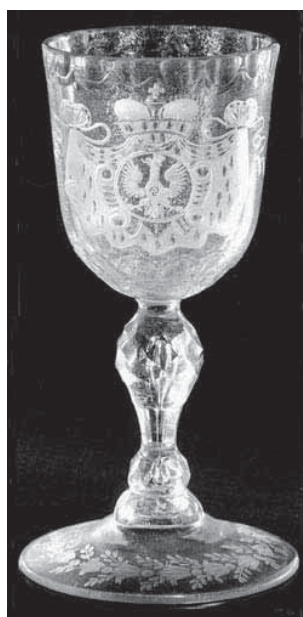
Sensor after corrosion

after 2 months in 40% acetic acid at RT and 4 h boiling
