# MICROCLIMATE INDOOR MONITORING FOR CULTURAL HERITAGE

M.Odyha<sup>1</sup>, N.Wade<sup>1</sup>, R.Campana<sup>1</sup>, J.M.Slater<sup>1</sup>, C.Theodorakopoulos<sup>1</sup>,  
F.De Santis<sup>2</sup>, V.A.Smith<sup>3</sup>, L.Bullock<sup>4</sup>, M.Rhyl Svendsen<sup>5</sup>, T.Padfield<sup>5</sup>, J.J.Boon<sup>6</sup>, E.Ferreira<sup>6</sup>

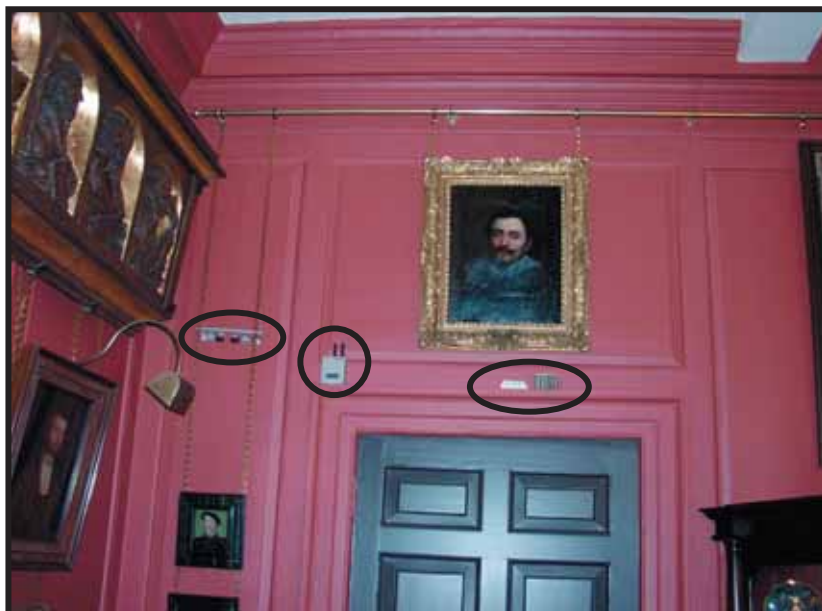
*Figure 1: Microclimate monitoring in English Heritage Ranger's House, Red Evocation room (Wernher collection). Data loggers from left show pollutant samplers, RH and T and MIMIC PQC passive box and palette*

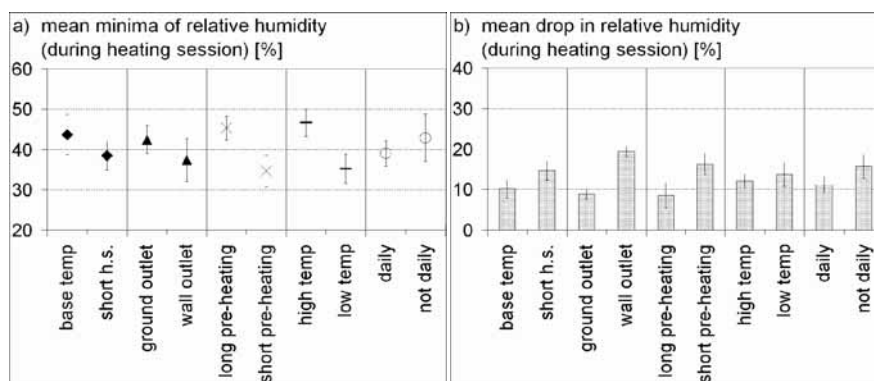
Figure 1a, b: Relative Humidity in function of the analyzed features

The relative humidity (RH) of the indoor air decreases when warmed up. Figure 1a on poster shows the average of the minima recorded during the heating sessions: under 40% for hot air heating with (i) short heating sessions, (ii) wall outlet, (iii) short pre-heating and (iv) low heating temperature – due to the substantial temperature increase (see fig. D on poster). The mean drop in RH is highest for churches with wall outlet (19.4%) and short pre-heating (16.3%).

As low values of relative humidity and repeated drops may result in cracks and loosening of wooden interior [5, 2] as well as paintings on wood and textiles suffer heavily from cyclic relative humidity variations [1, 6], heating the church only for services, especially with wall outlets and short pre-heating should be avoided if such objects are present (fig. 1).

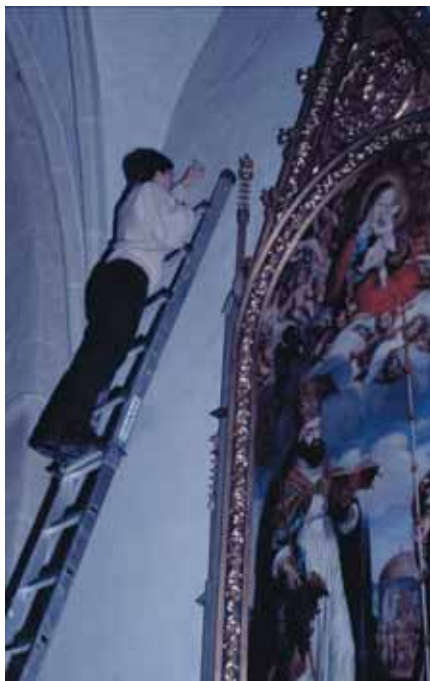
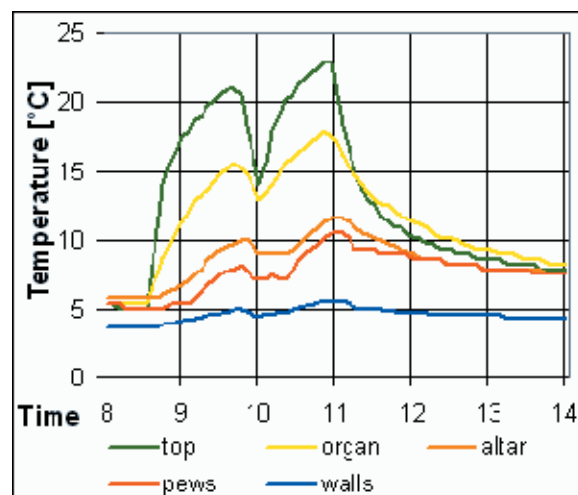
Figure 1: Installation of autonomous data logger for indoor climate monitoring in a church (left) and typical temperature development in a church with hot air heating and short heating sessions (right)

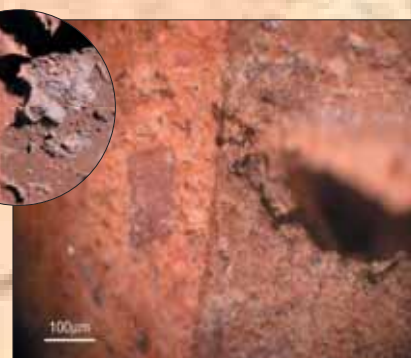
Sample of Ctesiphon brick jointed and substituted with geopolymer. Microscopy points out a geopolymer-brick edge.

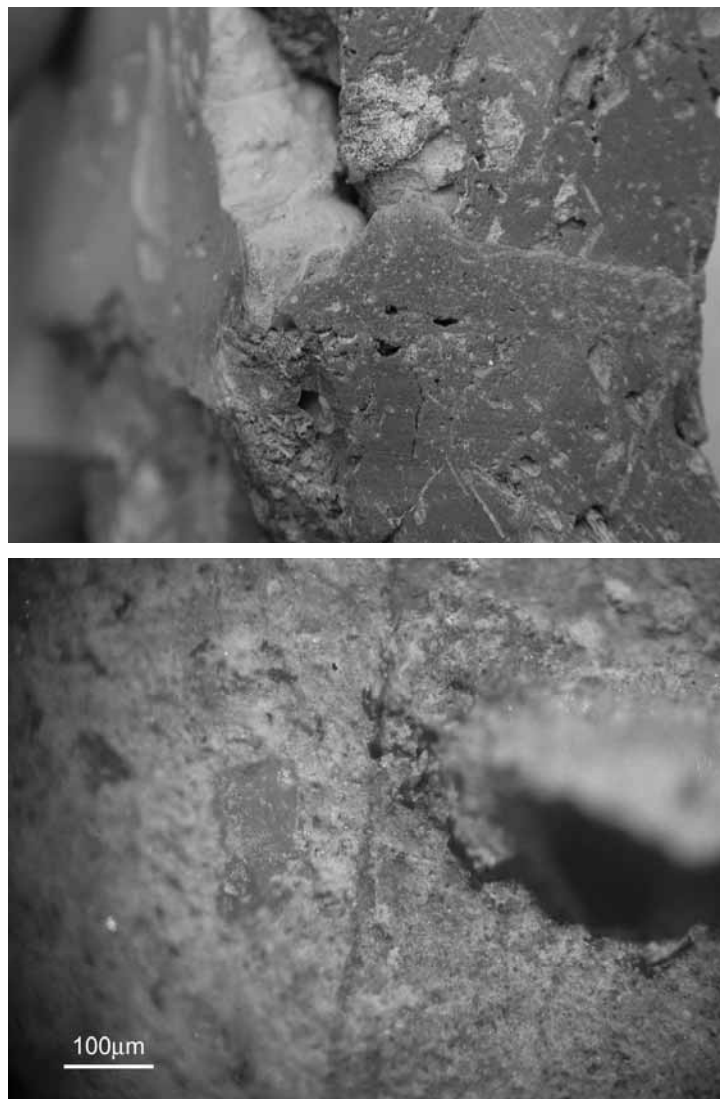
*Figure 1: Joint connection using geopolymer putty*

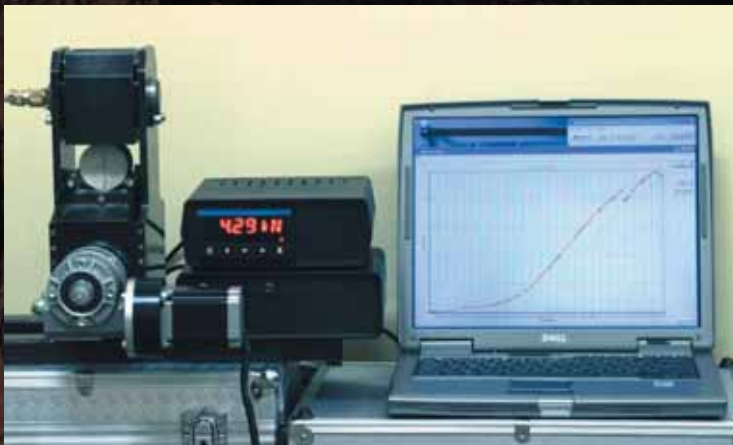
Fig. 1: Complete portable testing setup during split tests. The testing device equipped with stepper engine is operated by laptop with software for data acquisition and analysis. An accessory gear-box is inserted between the stepper engine and the loading screw in this case. Loading displacement data are obtained non-directly by counting the loading screw revolutions. The maximal displacement velocity is 1 mm/min in the case of the stepper engine in use.

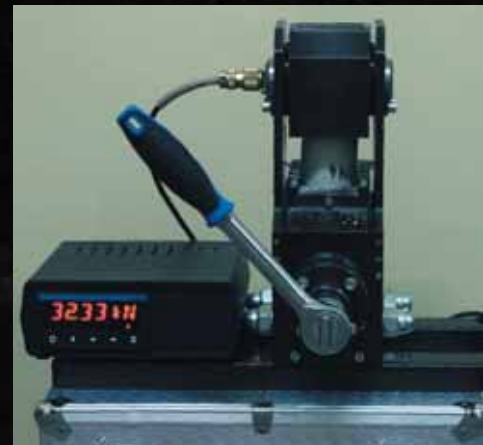
Fig. 2: Portable testing device with manual loading during compression tests. Screw rotation is carried out manually using a ratchet wrench. Only the maximal loading force is measured using this layout.
