Assessment Of The Durability Of Two Natural Stones Intended For The Conservation Of The Historical Masonry Sea Wall In The Old Town of Acre

Dr. Irena Wasserman,

National Building Research Institute (NBRI), Technion – Israel Institute of Technology, Technion City, Haifa 32000, Israel

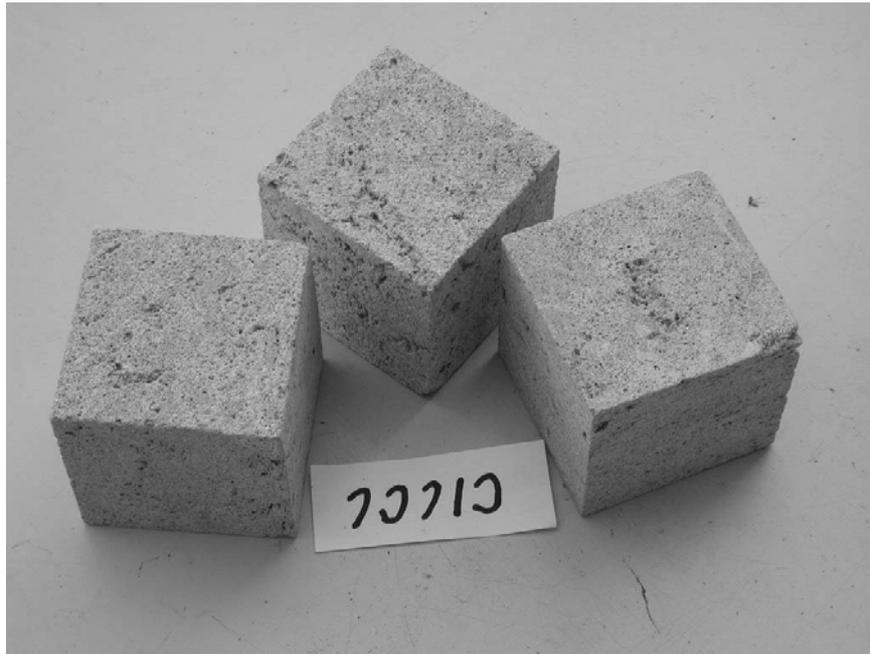
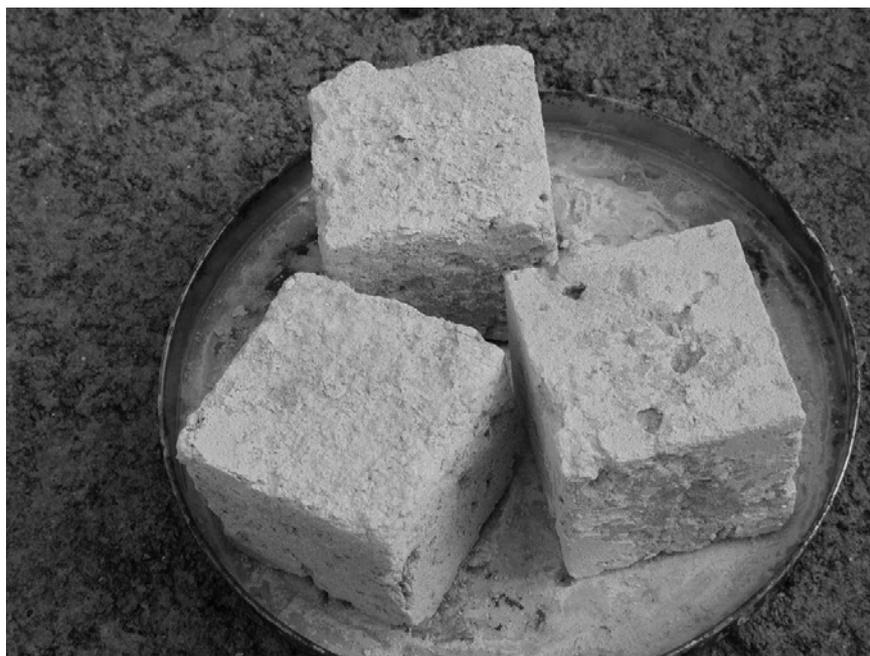
Fig. 6. Visual observations of the grayish sandstone before (a) and after (b) the crystallization test

The visual observations of the stones before and after the test are given in Fig. 6-7

The efflorescence phenomenon was observed in the investigated stones after the test. The deterioration of the grayish sandstone was much more obvious than that of the crème limestone. Crumbling of the sandstone began after 2 cycles of the test. In spite of it, the limestone crumbled slightly only after 9 cycles.

absorption let suggest that the capillary pores makes up just more than a half of the open porosity in the investigated stones. There are a lot of the large pores and caverns in the stones. These pores and caverns are clearly visible to the unaided eye (see Fig. 6-7).

The crystallization test strongly affected the investigated stones, especially the grayish sandstone. This stone strongly deteriorated as a result of sodium sulfate crystallization. Crumbling of the grayish sandstone began at the most early stages of the test. Probable, the non-homogenous mineralogical composition of the grayish sandstone and destruction of the secondary minerals caused the accelerated degradation of the stone.

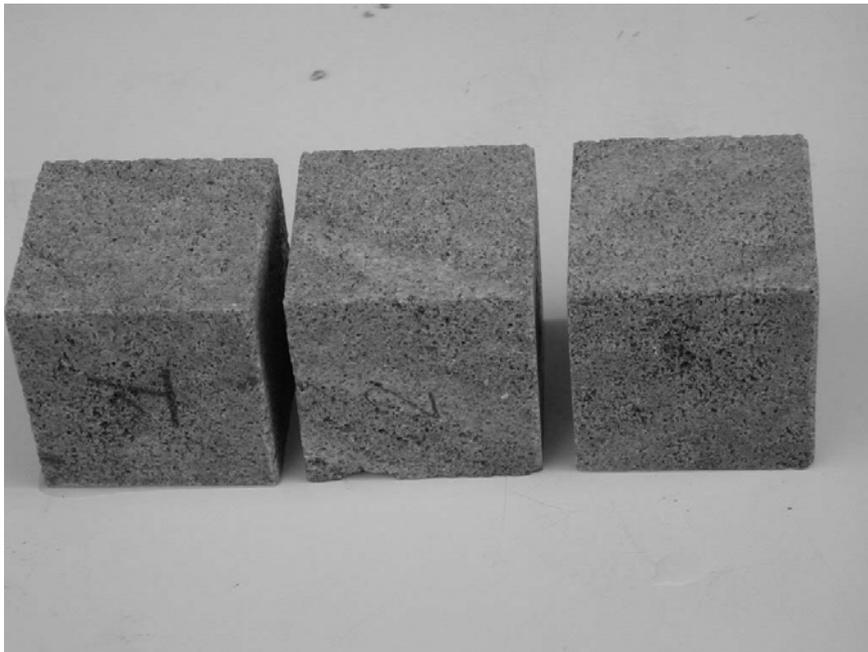
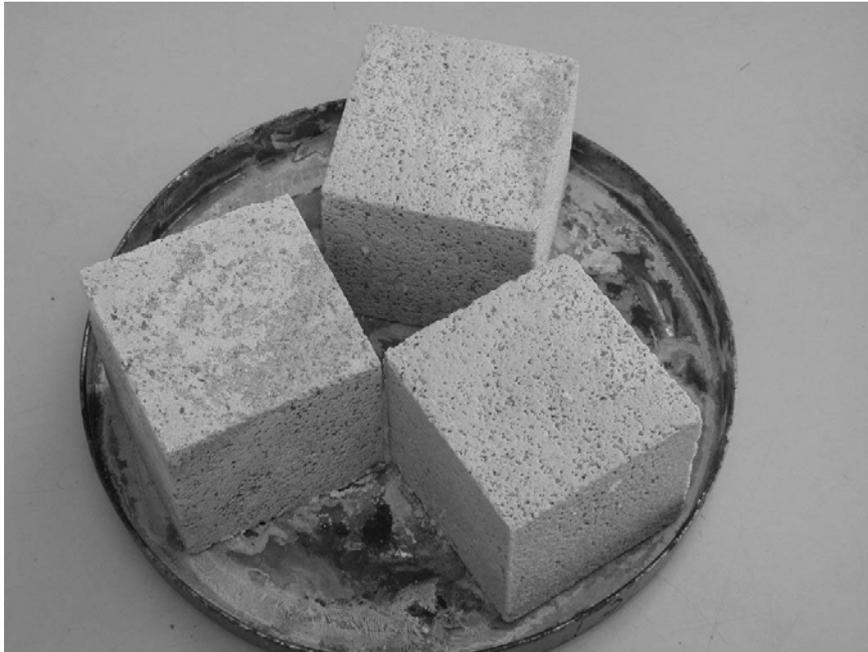
Fig. 7. Visual observations of the crème limestone before (a) and after (b) the crystallization test

The crème limestone was obviously more durable in the conditions of sulfate 'attack'. There were not observed any signs of crumbling in the stone up to the ninth cycle.
