Restoration of Wooden Structures

Juhani Penttimikko, B.Sc, Md

Penttimikko consulting engineers Ltd, Finland, mobile+358400459496

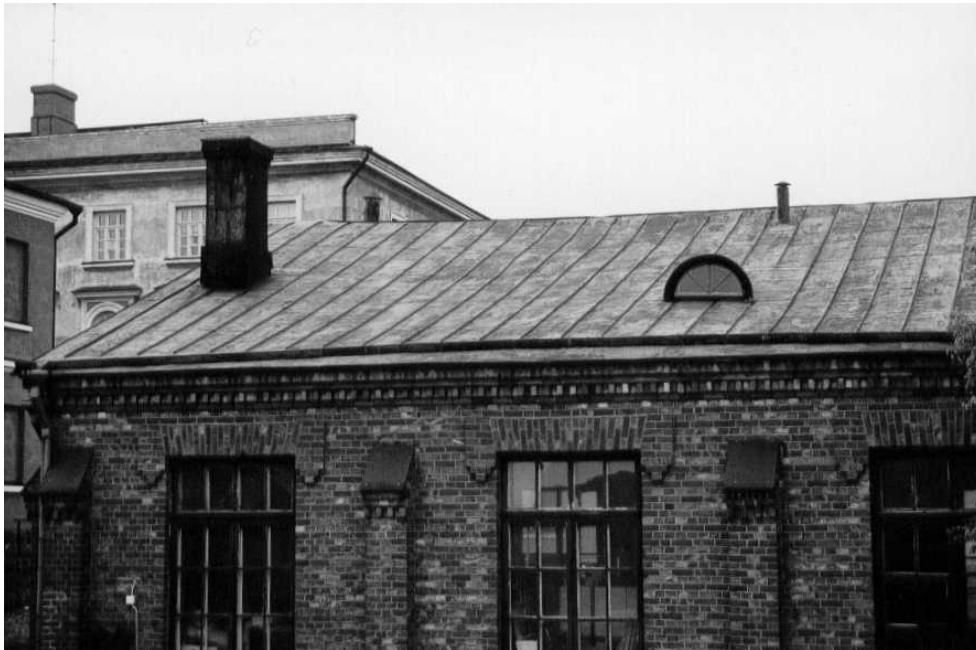
11. Artillery manege

When I surveyed the condition of Suomenlinna's manege C 81 almost ten years ago, I found alarming rot in the roof's lattice girders. The otherwise uninsulated roof structure had at some point been insulated by mineralwool jusa under the gutter area. Roof leaks and damperroof's condensation had got into the glass wool, and that's why the girders were rotting. The building served at that time as Suomenlinna's labour colony's warehouse, and it was not easy to find them a replacement quickly for the time of the reparation. At last such a place was completed in 2000.

The roof reparation was begun in January 2001. The work was done by the convict labour. After the starting difficulties the labour learned the right methods, and the project quickly progressed. Today all the 20 girders are repaired, and the building will soon get a new tin roof. Convict carpenters developed with the work into skillful restauration experts.
