Biodegradation and Treatment of Ancient Wood in Slovakia

Ladislav Reinprecht

Technical University in Zvolen, T.G.Masaryka 24, Zvolen, SK-960 53, Slovak Republik

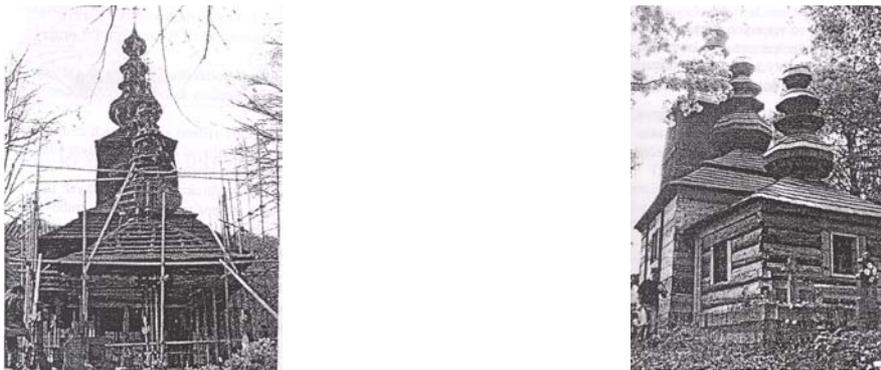
Figure 2: Wooden church in Hunkovce during and after renovation

Some of them are in a critical state and have to be renovated (Fig. 2).
